## FAILURE CASE STUDY SERIES PART TWO: FAILURE ANALYSIS OF ROLLER GUIDES IN A WIRE ROD ROLLING MILL

### ABSTRACT

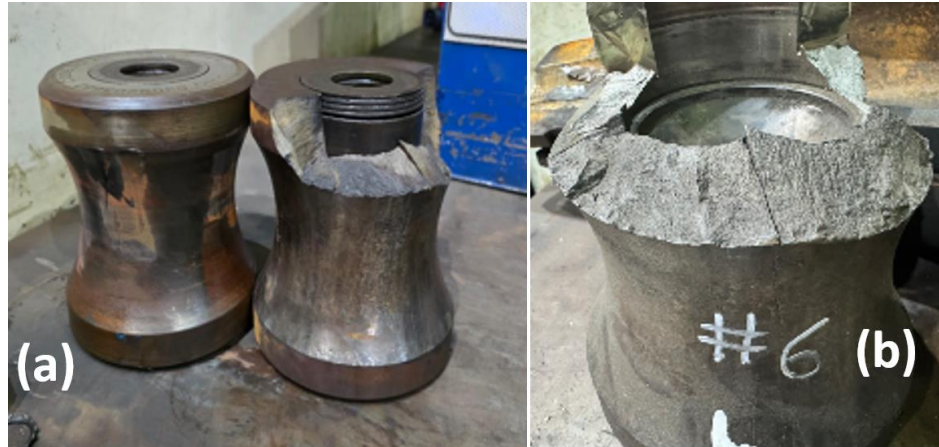
The guides failed during normal operation without any blockages in the rolling process (Figure 1). Visual inspection revealed prominent fire cracks on the rolling face of the component. These thermally

**Fig. 1.** Broken guide at site

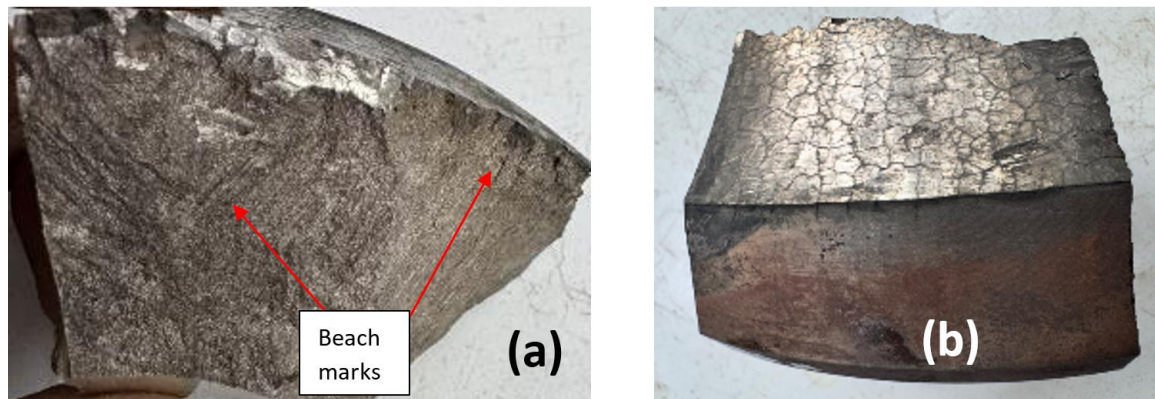
induced surface cracks are typically caused by rapid and repeated heating and cooling cycles during rolling operations, leading to localized thermal fatigue (Figure 2).

**Fig. 2.** Failure surface: beach marks (a), fire cracks (b)

Visual inspection revealed prominent fire cracks on the rolling face of the component. These thermally induced surface cracks are typically caused by rapid and repeated heating and cooling cycles during rolling operations, leading to localized thermal fatigue.

Such fire cracks serve as stress concentrators and can significantly reduce the fatigue resistance of the material. Under cyclic loading, they provide favourable conditions for fatigue crack initiation and propagation, which can ultimately result in premature fatigue failure of the component.

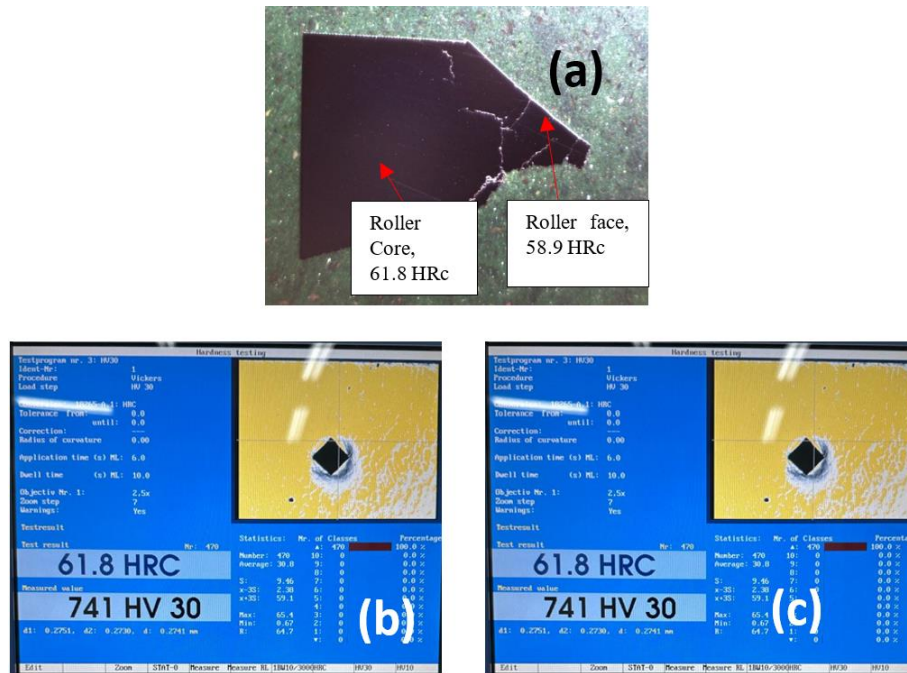
Hardness testing was performed on the roller surface [rolling face] region as well as the core region to evaluate potential hardness variations. However, no significant difference could be observed between the two regions. Both areas revealed very high hardness, on the order of approximately 60 HRC (Figure 3).

**Fig. 3.** Vickers and Rockwell hardness (a) roller core, (b) roller side

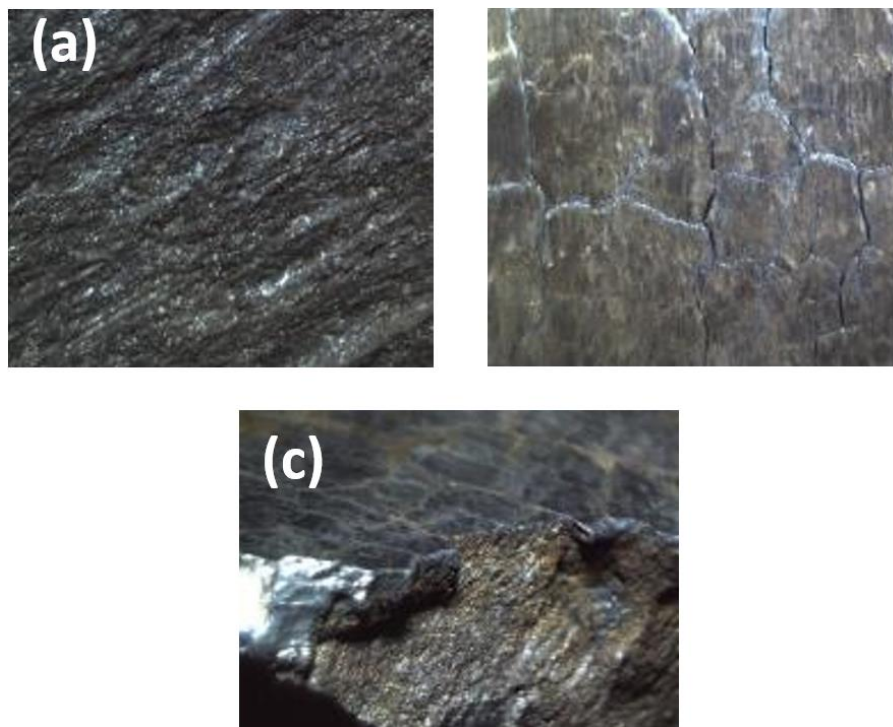
**Fig. 4.** Beach marks visible on the fracture surface (a); Prominent fire cracks observed all around the rolling face of roller guide (b); Separation (fracture) found to be occurring along fire crack planes (c)

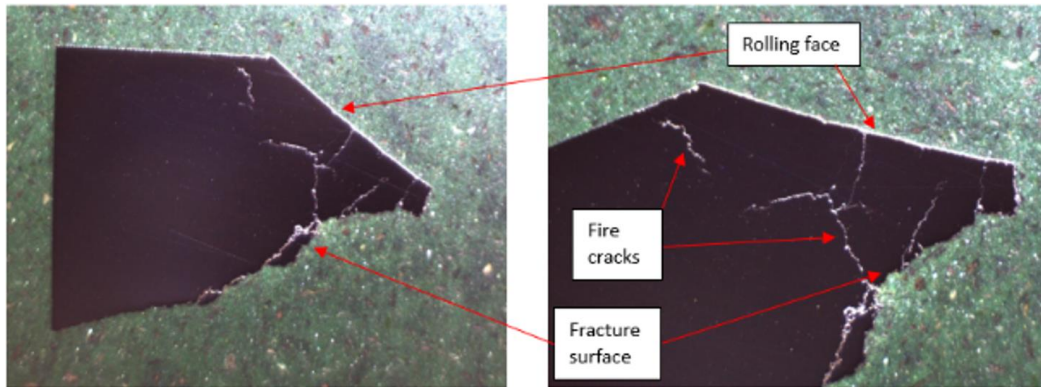
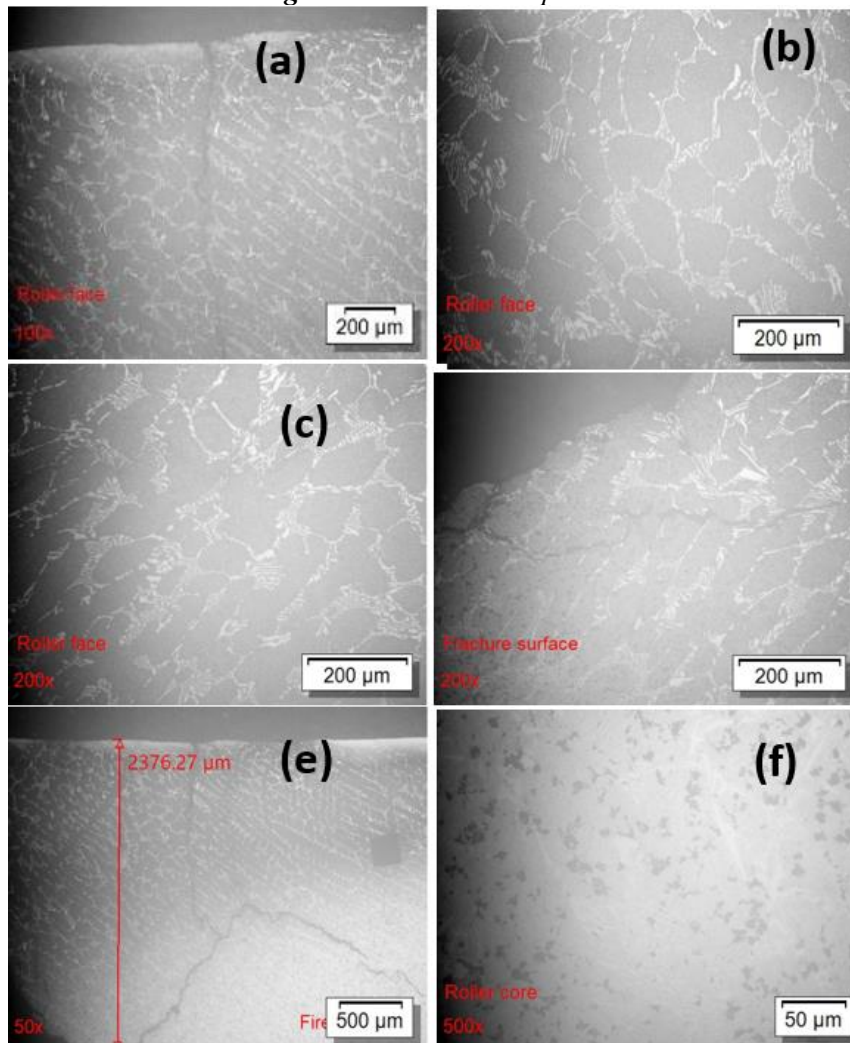
Fig. 6. OM microstructures, (a) Roller face Micro-image, (b) Fire cracks can be seen, (c) Roller face region, (d) Micro-image, Depth of fire crack > 2.376 mm

The sample was found to have higher sulphide inclusions on the order of 2.0 (thin series). It was fairly clean and free from any harmful inclusions / exogenous entrapment. No surface hardening was found to have been given to the part. The hardness and microstructures were homogeneous throughout the sample. Because surface hardening gives better fatigue life. Metallographic examination revealed a homogeneous microstructure throughout the roller guide cross-section. There was no indication of surface hardening treatments such as induction or flame hardening. The uniform hardness profile suggests the part was likely used in a normalized or

cold-drawn condition. Surface hardening techniques are known to significantly improve fatigue life, especially in components subjected to cyclic or torsional stresses like roller guides.

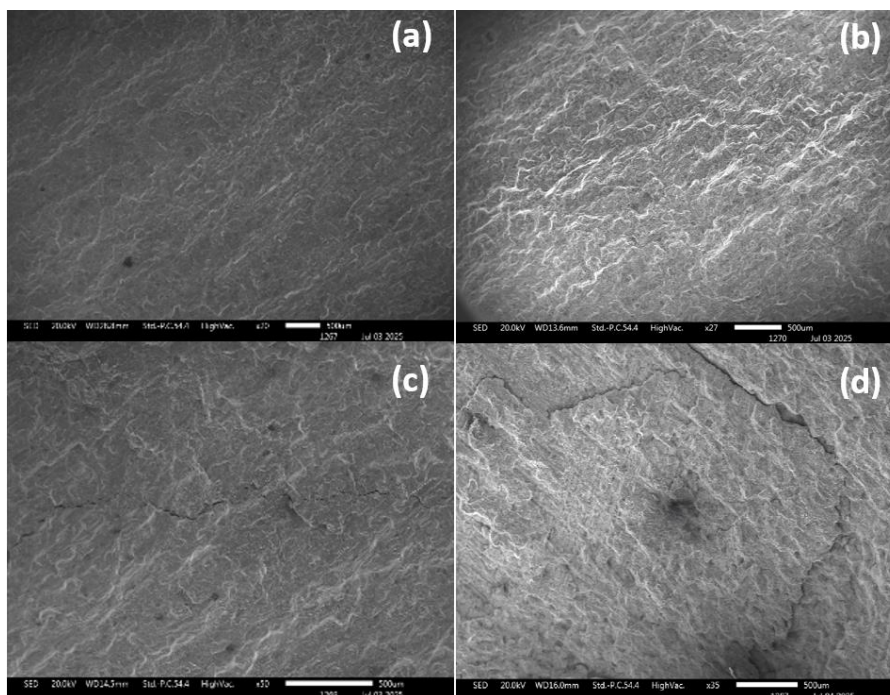
**Fig. 7.** SEM micrographs, (a and b) beach marks crack propagation, (c) secondary cracks, (d) fatigue crack initiation

A typical intergranular fractured surface was revealed throughout the sample (Figure 7). This fracture surface displays a characteristic intergranular fracture mode, meaning the cracks propagated along grain boundaries rather than through the grains themselves. The distinctive features visible are individual grains with well-defined boundaries,

Evident outlines of individual grains indicate that the separation occurred along grain boundaries, suggesting grain boundary weakness. The sharp edges suggest that minimal deformation occurred during the fracture, which is consistent with a brittle fracture mode.

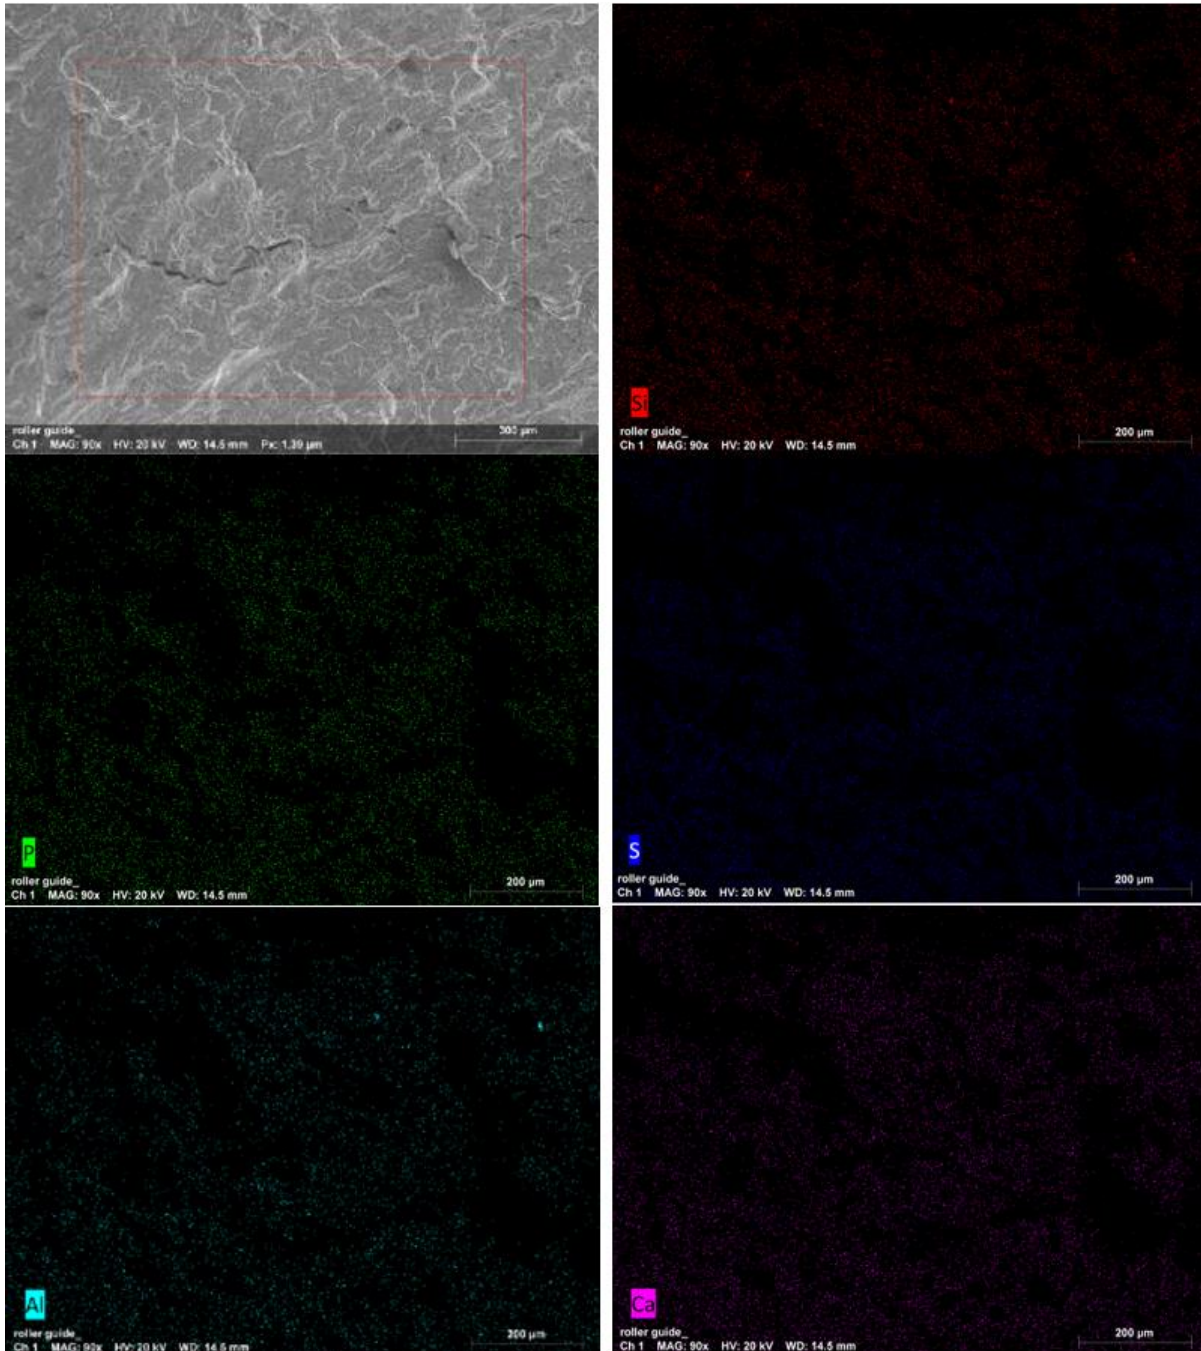
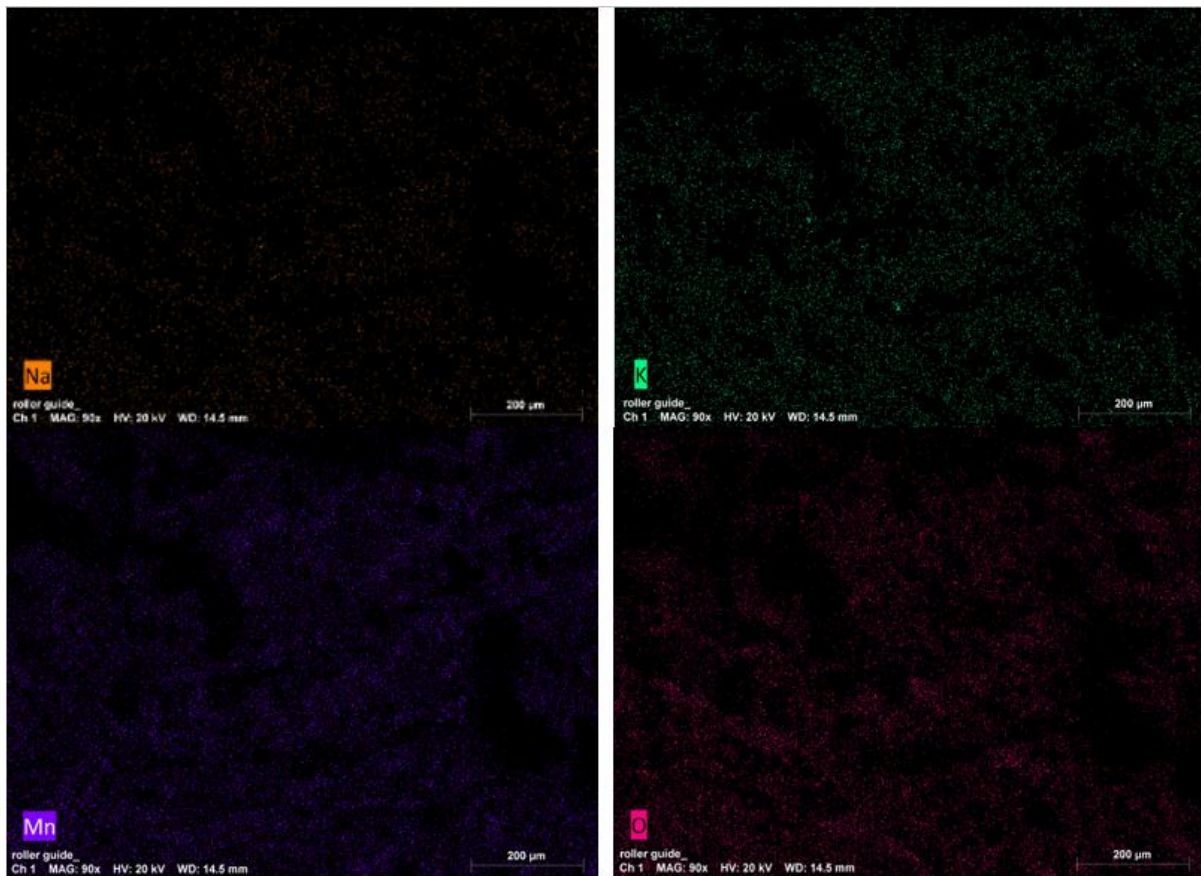
*Fig. 8. EDS mapping of the chemical element distribution*

As suggested by the arrangement of the elemental distribution on the EDS map (Figure 8), the intergranular fracture surface reveals a homogeneous dispersion of alloying elements.
