FAILURE CASE STUDY SERIES PART THREE: INVESTIGATION OF WEAR AND FAILURE MECHANISMS IN HEAVY-DUTY GEAR COUPLING

KEYWORDS: failure analysis, gear-coupling, OM, SEM, EDS

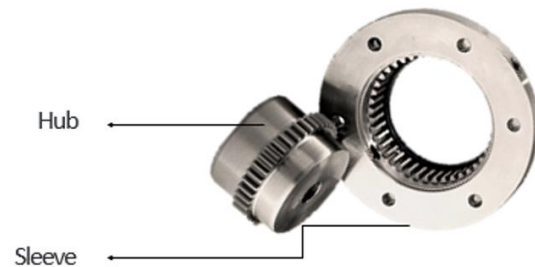
Fig. 1. Gear coupling

The investigations were conducted on both the hub and sleeve of the gear coupling (Figure 1).

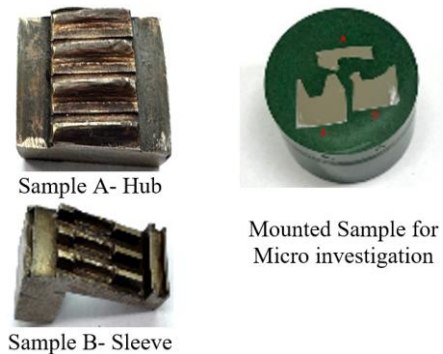
Fig. 2. Samples for hardness investigation (A) hub (B) sleeve

Sample A (Hub) exhibits slightly higher hardness values at both the tooth tip (233 HV30) and core (234 HV30) compared to Sample B (Sleeve), which shows hardness values of 212 HV30 at the tooth tip and 220 HV30 at the core. This indicates that the hub material is marginally harder than the sleeve, which is consistent with its higher carbon content (Figure 3).

The lower hardness in the sleeve suggests it has comparatively less wear resistance, which likely contributed to the severe abrasive wear and tooth failure observed in the sleeve. Additionally, the small hardness difference between the tooth tip and core in the sleeve indicates a lack of surface hardening, making the teeth more vulnerable to wear under high contact stresses.

A practical pairing recommendation in the case of a sacrificial sleeve concept (controlled) is: Hub: ~300–340 HB; Sleeve: ~270–310 HB ($\approx -15-30$ HB vs. hub), with strict lubrication control and inspection intervals.

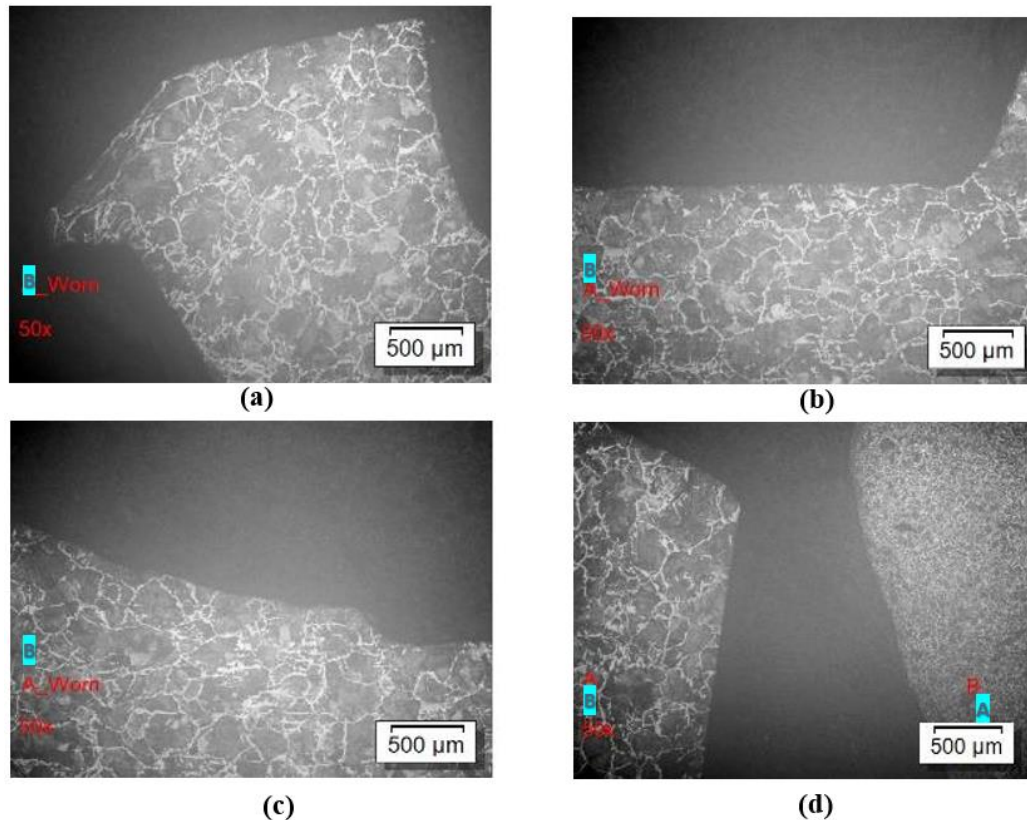
Fig. 4. OM microstructures: (a) Sleeve sample: Tooth tip regions did not reveal any hard microstructure, indicating no case hardening was applied; (b) Sleeve sample: Tooth-damage region showing a normal ferrite-pearlitic microstructure; (c) Sleeve sample: Tooth-damage region showing a normal ferrite-pearlitic microstructure; (d) Both samples' microstructure are ferrite-pearlitic. Hub Sample (A) shows significantly finer structure

Both the hub (Sample A) and sleeve (Sample B) show ferrite-pearlite microstructures, indicating that both components were produced from plain carbon steel or similar low-alloy steel. The hub sample exhibited a significantly finer microstructure compared to that of the sleeve sample.

No evidence of case hardening was observed in either the tooth tips or tooth damage regions. Both samples exhibit microstructures consistent with non-surface-hardened steels.

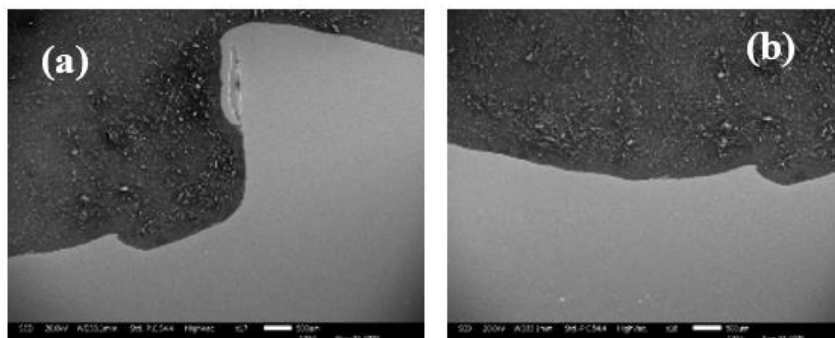
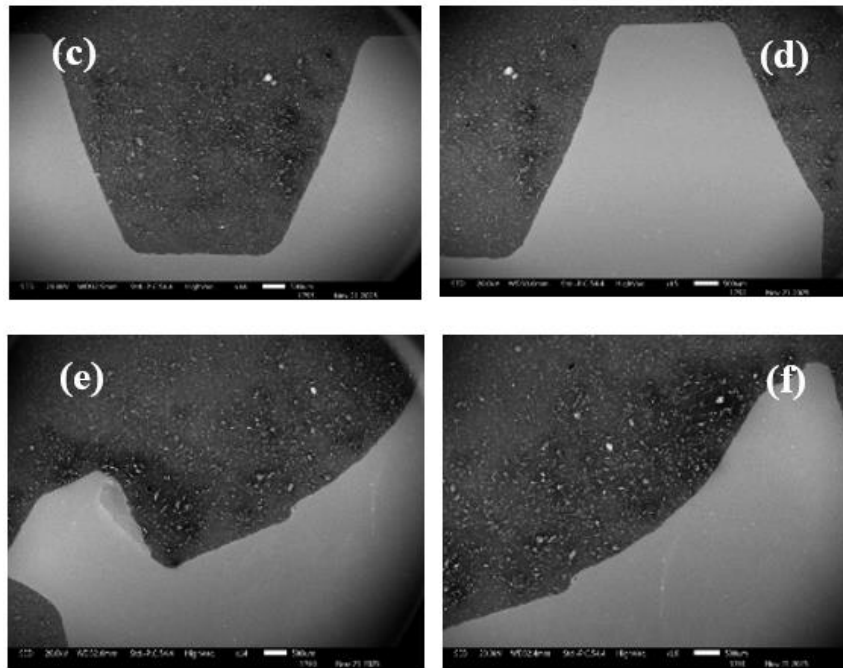
Fig. 5. SEM micrographs; (a) Hub -A Tooth region; (b) Hub-A worn out region; (c) Sleeve B tooth region; (d, e, f) Sleeve-B worn region

No material-related abnormalities were observed in the SEM (Figure 5) examination of either the hub or the sleeve. The worn regions showed no

inclusions, defects, or compositional anomalies, confirming that the material quality did not contribute to the observed damage.

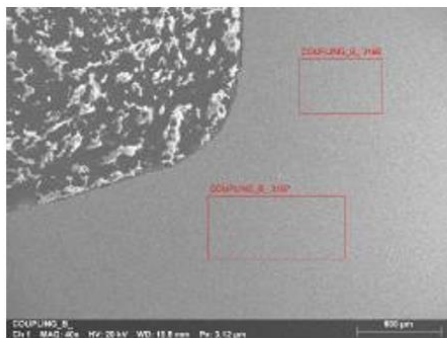
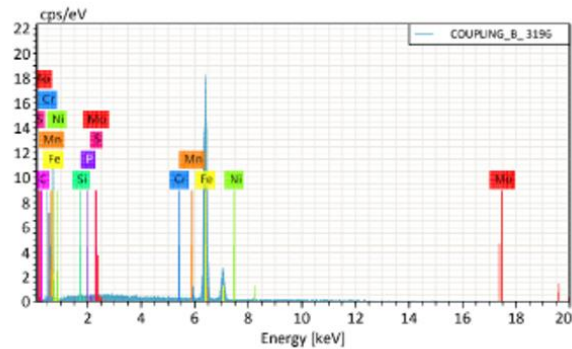
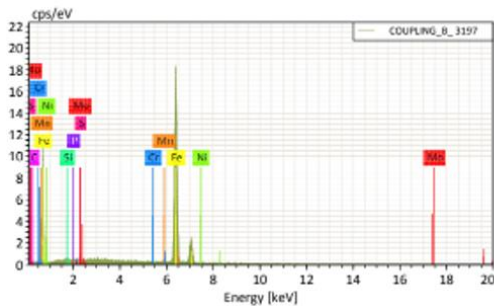
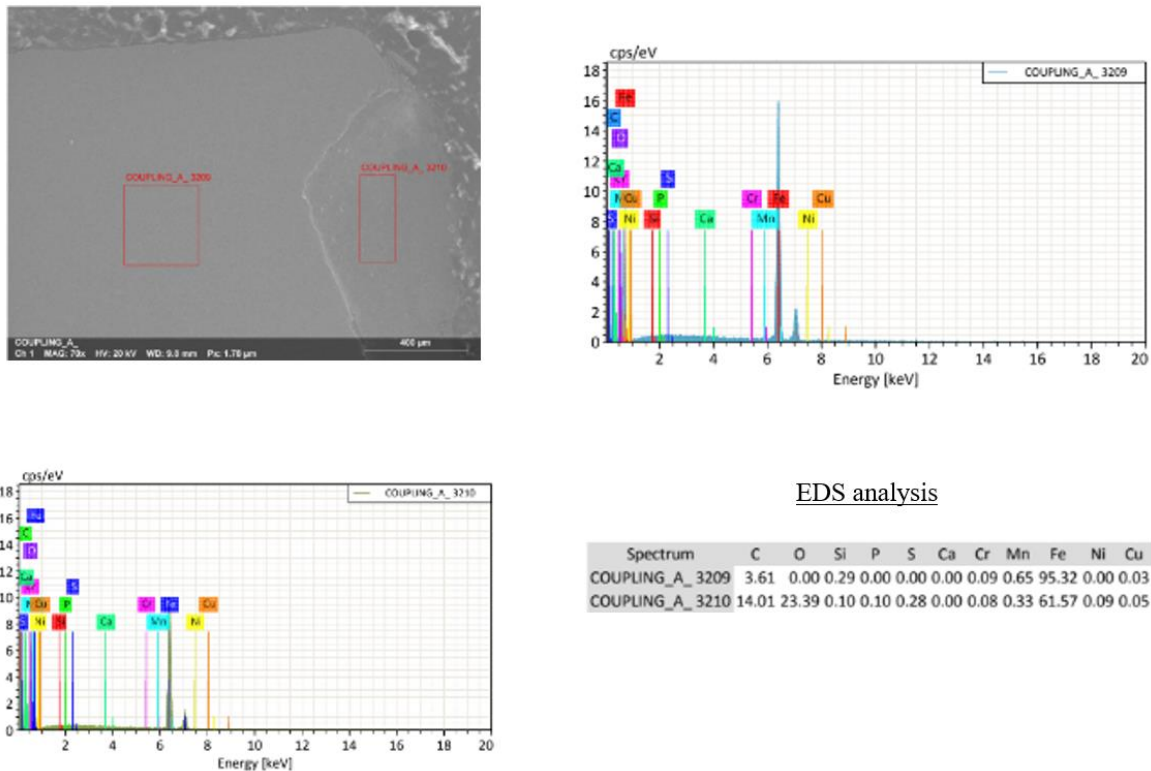
Fig. 6. EDS spectra on both sleeve and hub tooth

Spectrum	C	Si	P	S	Cr	Mn	Fe	Ni	Mo
COUPLING_B_3196	4.33	0.14	0.02	0.00	0.05	0.41	94.63	0.22	0.20
COUPLING_B_3197	3.61	0.30	0.01	0.00	0.00	0.42	95.65	0.00	0.01

The EDS results closely match the measured chemical composition, confirming that the material was manufactured according to standard conditions and did not play a significant role in the coupler’s failure.
