## IMPORTANCE OF PERIODICAL EXAMINATION AND MAINTENANCE OF PROPELLERS FOR ENSURING SEA- WORTHINESS OF CARGO VESSELS

### ABSTRACT

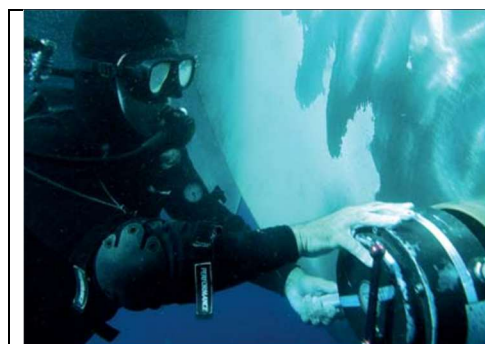
**Figure 3** Underwater mechanical polishing on NAB propeller of biofouling, during in water survey [14]

performed for the propeller, exposed part of stern tube bush, sealing glands, fastenings and clearances.[12] Of particular importance is the surface of the propeller. Although most of the commercial vessels are equipped with Nickel Aluminium Bronze (NAB) propeller, material with augmented performance in the harsh marine environment due to its commendable corrosion and wear resistance [15], propellers are still prone to biofouling attachments. Under this unwanted reality, propeller efficiency is adversely affected. Starting from the surface roughness determined by the barnacle adhesion, Wang et al. performed CDF numerical simulation in order to evaluate the negative impact. However, it has been noticed that flow separation and horseshoe vortices appear on the surface contaminated with biofouling, leading to a decrease of the propeller efficiency up to 40%.[13] To efficiently counter the deleterious effect of barnacles upon the hydrodynamic efficiency of the propeller, maintenance works are carried out during periodical surveys by mechanical polishing of the blades surfaces, as highlighted in figure 3.

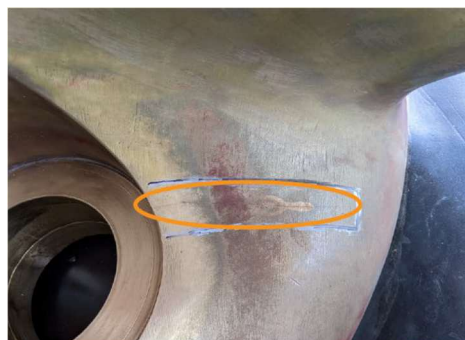
a) Surface cracks on blade no 2

**Figure 7** Propeller failure due to cracks, as reported by investigation assessment [23]

oil leak in the controllable pitch propeller system. Despite the best efforts of the crew, the situation could not be rectified on board and the vessel commenced dry dock for the evaluation of damages and restauration of the system. However, during close up examination of the propeller in dry dock, it has been ascertained by the responsible Classification Society and Coast Guard inspectors that leakages occurred because of fractures of the propeller material in the hub of two blades, in the vicinity of bolts, as depicted below in figure 6.

As a result of the investigation consisting in mechanical tests, chemical composition test and FEM simulation, it was concluded that crack fracture occurred due to material high cycle fatigue and because of lack of meeting propeller manufacturer design specification for bolt hole counterbore radius. [23]
