# NON-CONFORMITIES ANALYSIS IN THE INDUSTRIAL MANUFACTURING PROCESSES

The current article presents the identification, treatment method and encoding of causes that generate defects and types of non-conformities encountered during the manufacturing process in industry.

This article aims to analyse how to deal with non-conformities occurring in the manufacturing of turbine components, generators and compressors used in energy industry.

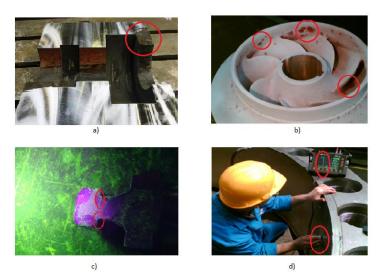
*Fig. 1.* Non-conformities identified following inspection: a) visual; b) penetrating fluids; c) magnetic powders; d) ultrasound

For deviations identified by visual inspection (see Fig. 1), chemical analysis, mechanical tests, hydraulic or pneumatic probes, the records issued (test bulletins, photo if defects are visible – see Fig. 2) are attached to the NR and are also mentioned therein.
